Pewsey Wharf Web Report

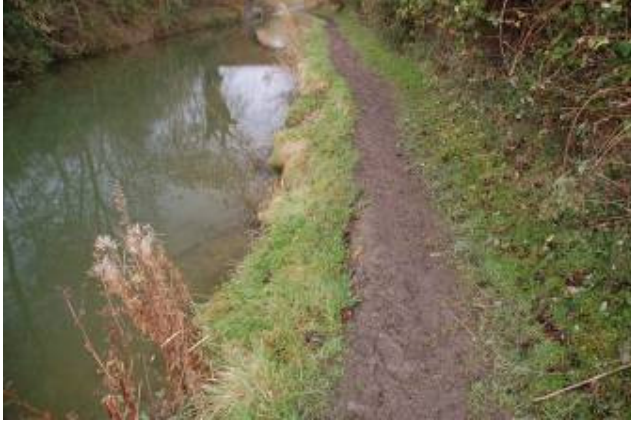
The towpath near Pain's Bridge was severely eroded and becoming a health and safety concern.

Erosive forces from the use of riverboat mooring pins, wash from passing craft, and general footpath erosion had caused considerable damage to the towpath

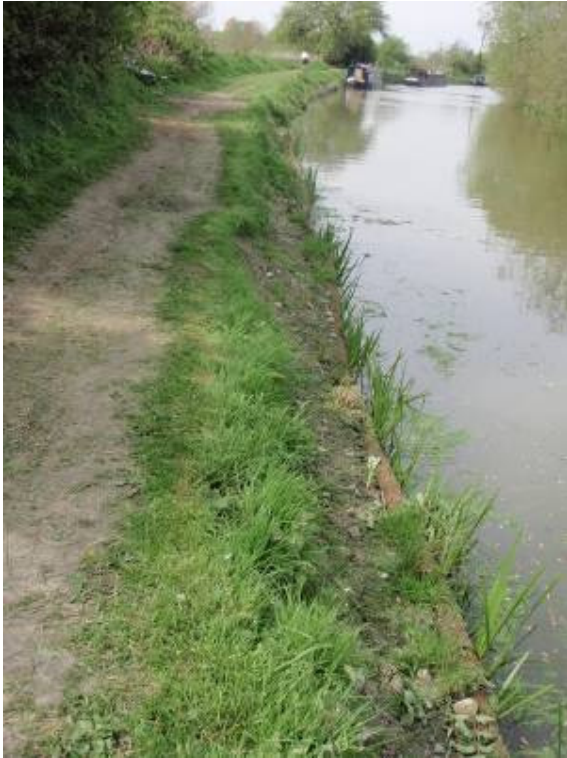
4 months later – plants safely established and helping to form a strong structure that would become stronger as plants developed dense root systems and formed thick tussocks along the bank.

Grasses had begun to encroach on the new structure and protect the remaining bare soil.

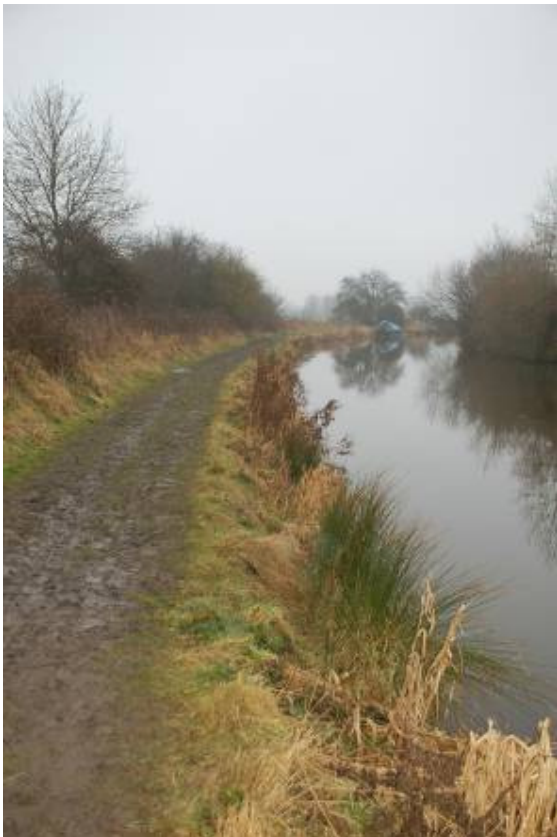
1 year on – the following winter.

Just one summer's growth has covered all the bare soil and dense tussocks have developed along the waters edge.

Grass growing through the rolled coir and helping to create a fully naturalistic margin

This winter the path is safe from erosion and the summer will see an explosion of growth

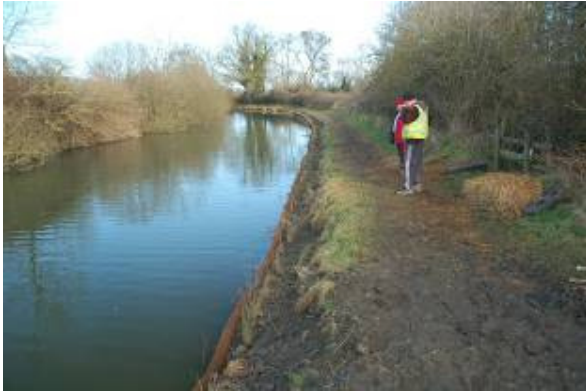
Early 2009
Structure completed

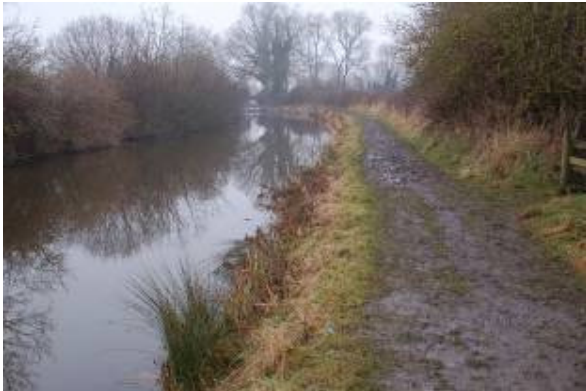
Early 2010
Developed into a naturalistic marginal habitat protected from erosion

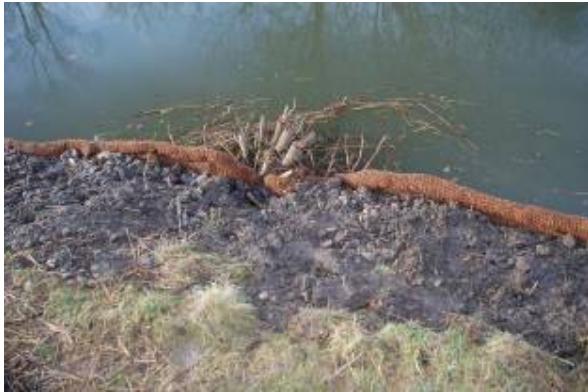
Early 2009
Small willow coppiced to allow access for works,
New bank installed

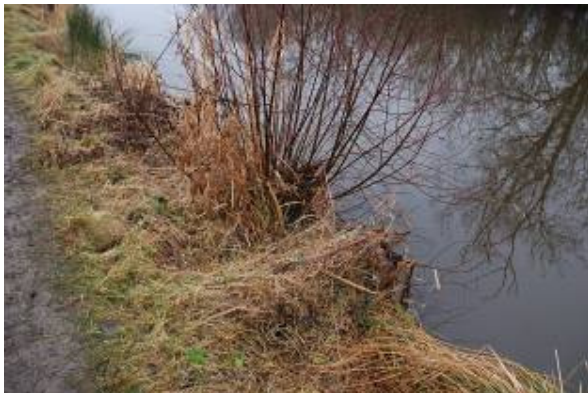
Early 2010
Willow re-growing and thick grasses and sedges covering structure

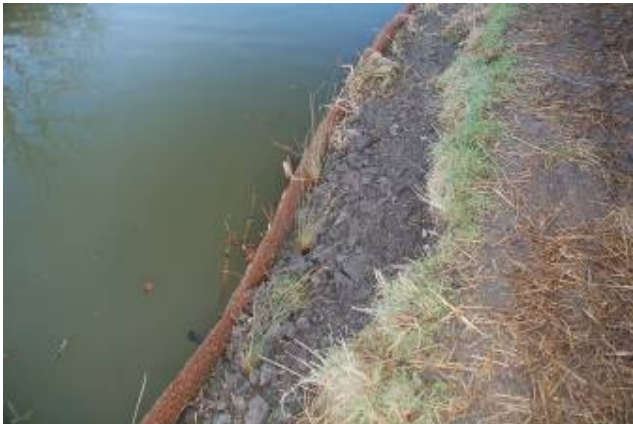
Early 2009

Hard rush (*Juncus Inflexus*) planted in new revetment

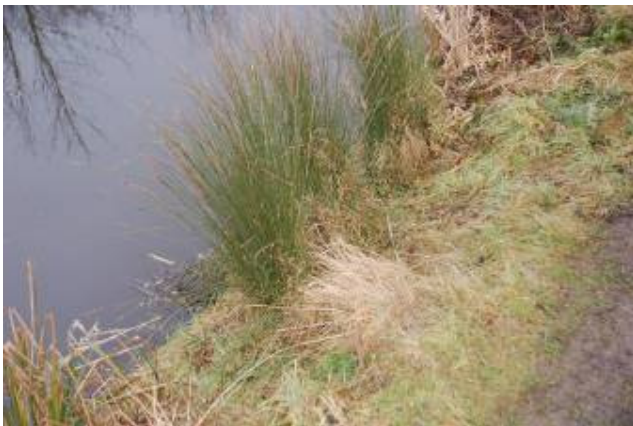
Early 2010

Dense tussocks forming, all soil covered and protected by thick vegetation
