## Bother on the River Rother!

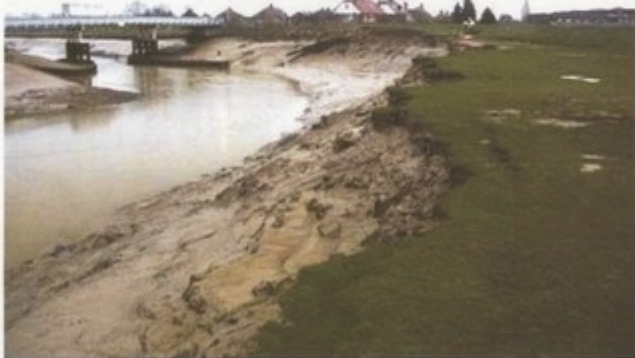
*Slumping bank - site of emergency works*

a deconstructing system intent on reclaiming its saltings. Whilst these processes enable an unconstrained river system to adapt to changing flow and sediment regimes, in a severely constrained one, these same in-channel changes are often a cause for concern. In an ideal situation the levees would be set back allowing the river to reclaim its floodplain, reducing the stress on banks. Extensive floodplain development prevents such an holistic approach at present and some banks are so degraded that emergency protection is essential to prevent a complete breach of the existing defences.

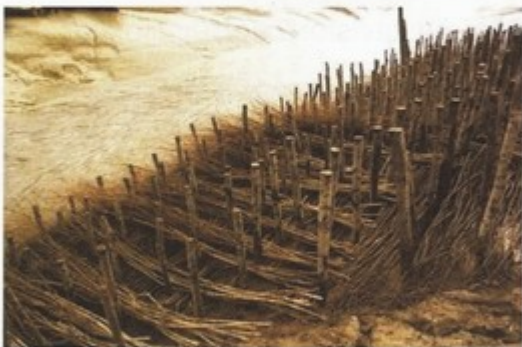
*Trial construction: more faggots than you can shake a stick at.*

provide an environmentally friendly, sustainable and cost effective alternative to sheet piling for the emergency bank protection work at Rye, Simon Cain thought big and adapted his relatively small brushwood structures for the job. A trial project was rapidly constructed to demonstrate the principles of the new technique. Within weeks of completion the bottom half of the structure was completely full of sediment with no noticeable adverse effects.

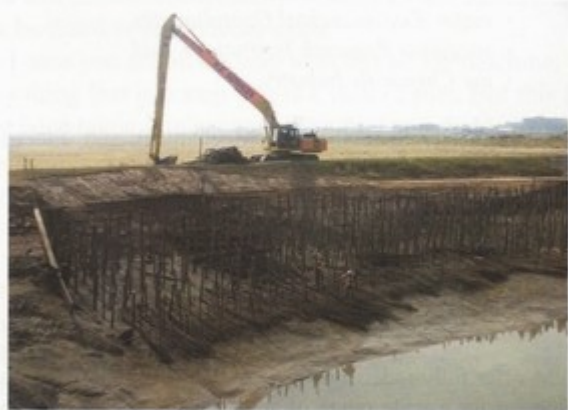
*22m reach Komatsu and two faggoters shows scale of works.*

With the backing of the Environment Agency, and in cooperation with their Emergency Work Force and Halcrow, construction has now started on the eroded bank near the town of Rye. All of those involved with the project have a lot of enthusiasm about the use of this technique. It provides an alternative to the costly and hard engineered bank protection measures and once covered with sediment should blend in with the surrounding landscape. Furthermore it uses wood derived from sustainable sources and at £0.5million would pass any cost-benefit analysis when compared to sheet piling a 120m x 4m deep section of eroding and highly unstable bank.

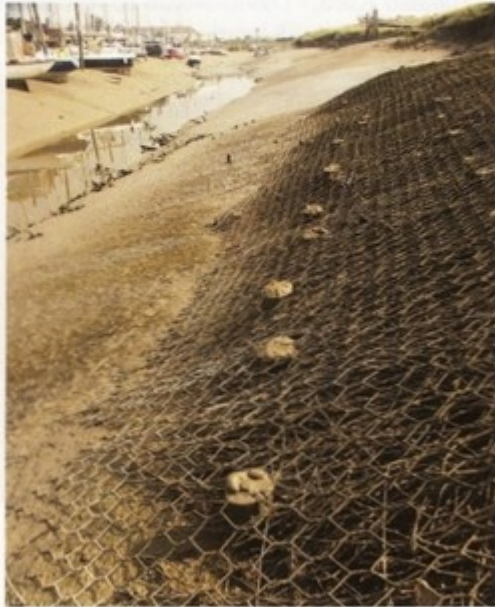
*Sedimentation at trial site*

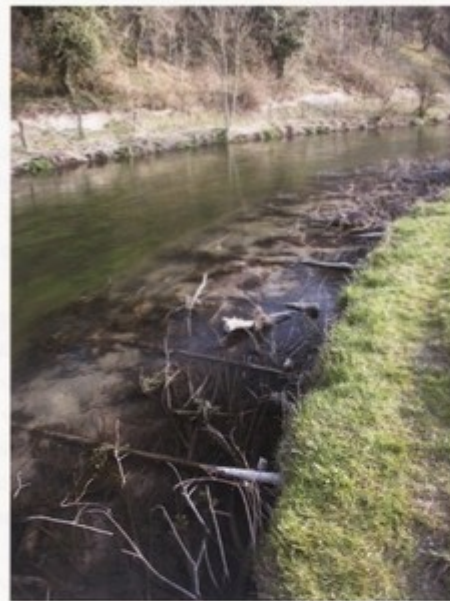
*Brushwood mattress on a chalk stream*

More recently, similar brushwood techniques have been successfully used by the Cain Consultancy to restore chalk streams and spate rivers. Their ability to protect and stabilise banks, create new marginal habitat, and crucially, to trap silt, has been demonstrated. So when asked to
