Engineered or not?

A case study of Summerlock Stream
Salisbury

Engineering the Green Way

A Case for Green Engineering in a SSSI Parkland Setting.

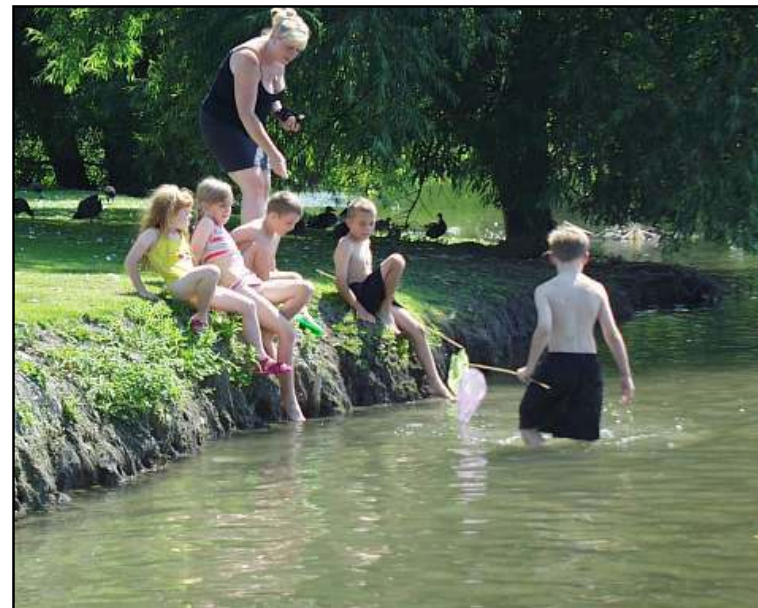
- Salisbury's Queen Elizabeth Gardens provide an important amenity for families and tourists during the warm summer months.
- Access is poor, so children have to 'bank-slide' into the river.

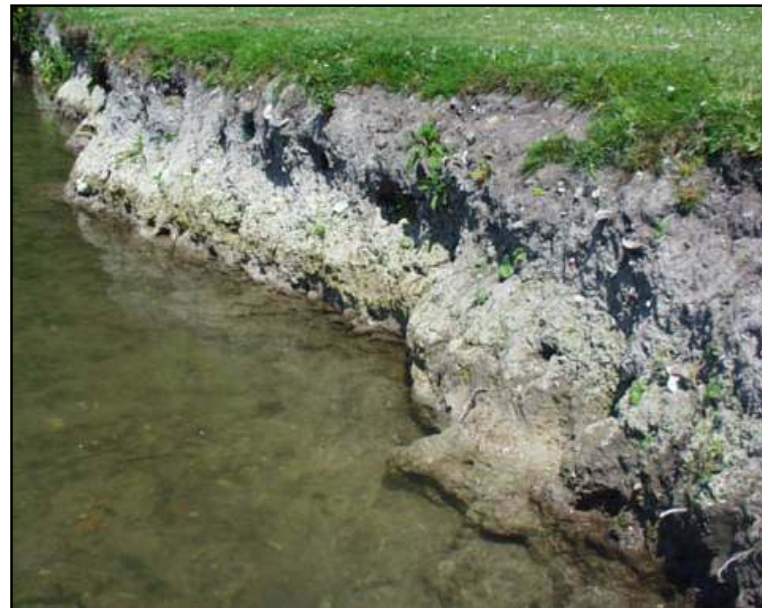
Bank 'Poaching'.

- Wholesale destruction of protective riparian vegetation has left the bank face bare and vulnerable to erosion.
- Rapid bank retreat and a significant loss of parkland has continued unchecked for years.

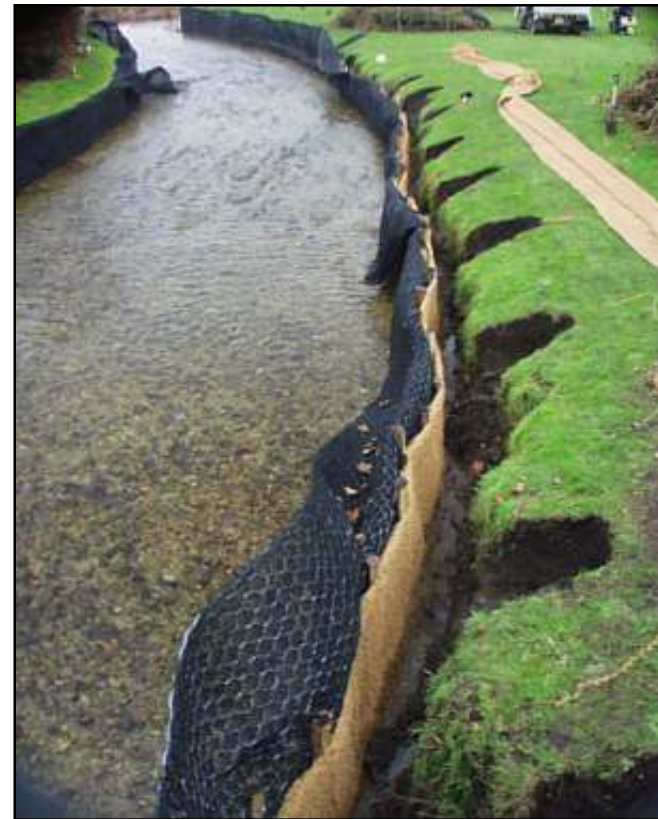
Design Specifications: Two part installation.

- 1) A vertical geotextile revetment to retain reclaimed land.
- 2) A secondary marginal shelf to improve public access to the river.
 - The structure combines traditional engineering materials with sustainable woodland products.
 - English Nature (Wiltshire Team) welcomed the experimental use of engineering materials, having carefully considered the limitations of the site.

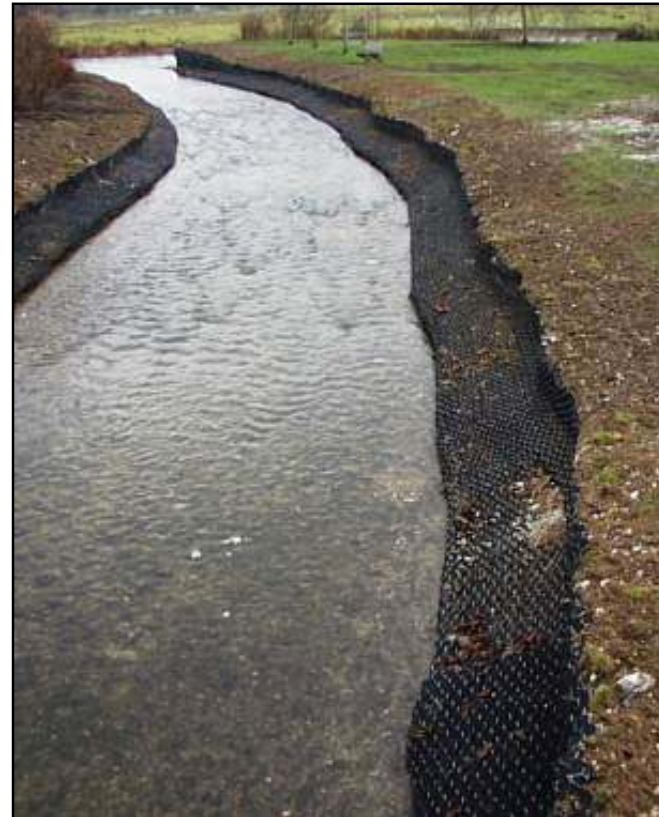
The 'Engineered' Structure.

- The structure on completion, presents a stark, engineered finish.
- The strips of soil on either bank indicate the degree of land reclamation and channel narrowing.
- The project was hydraulically modelled as part of the EA consenting process (flood prevention).

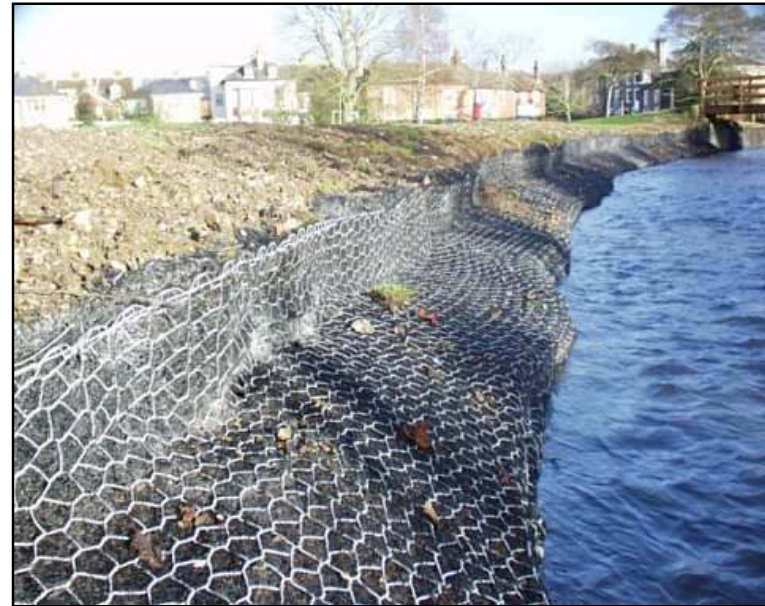
Detail: Completed Structure.

- The skilled use of rock netting enabled the construction team to mimic a sloping riverbank profile.
- The hard vertical face associated with traditional engineering schemes has been avoided.
- The engineering materials have a shelf life in excess of 100 years.
- The structure is accessible to plants, invertebrates, water voles and brook lamprey.

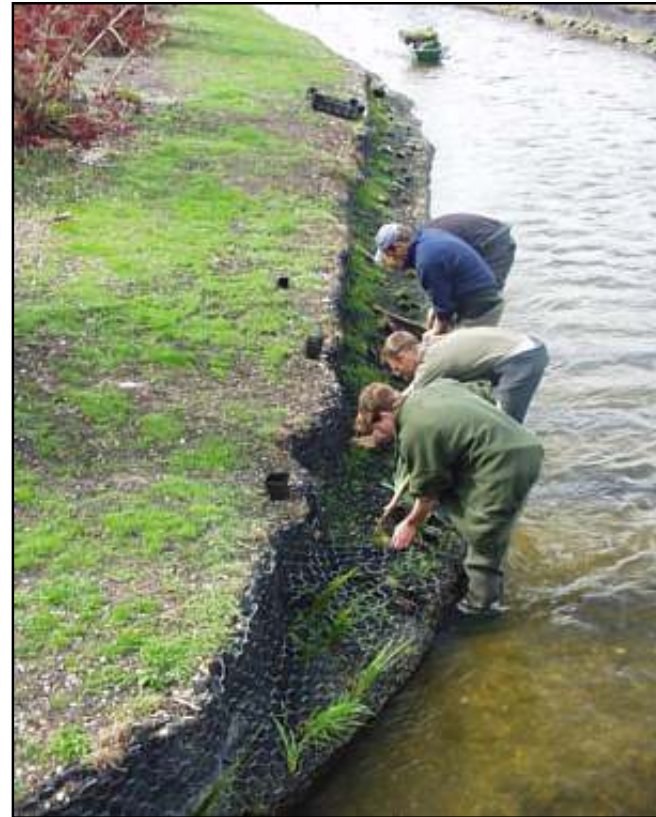
Introducing 'Bio' to the 'Engineering'.

- Over 15 species of native British plants were planted into the structure in the early spring.
- Root systems are essential to strengthen and consolidate the 'engineered' structure.
- Suspended solids are filtered from flood waters and the margins accrue on both banks.

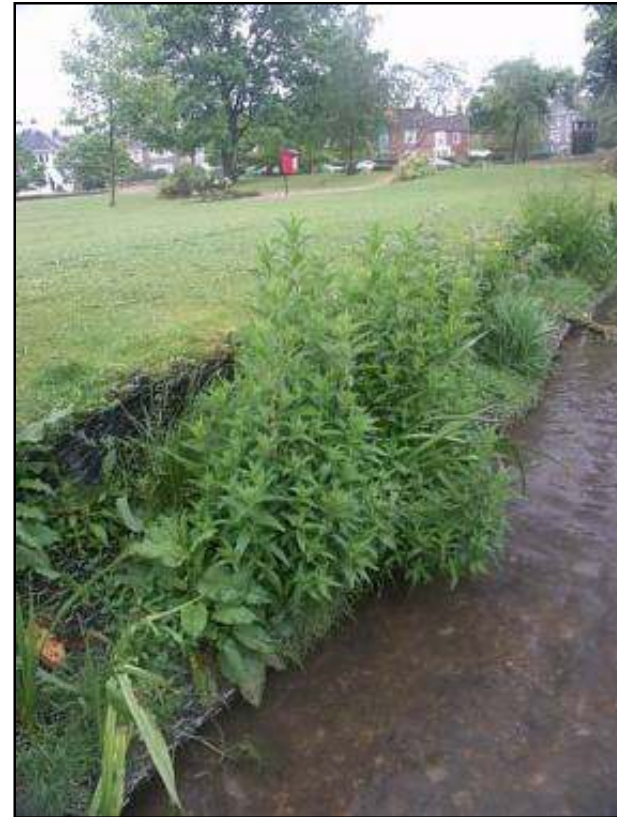
Plant Colonisation:

- Six months after project completion, plants have colonised over 50% of the revetment surface.
- Children can now step down onto the engineered riverbank at any point along its 120m length.
- The geotextile casing protects root systems from destructive pedestrian activity.

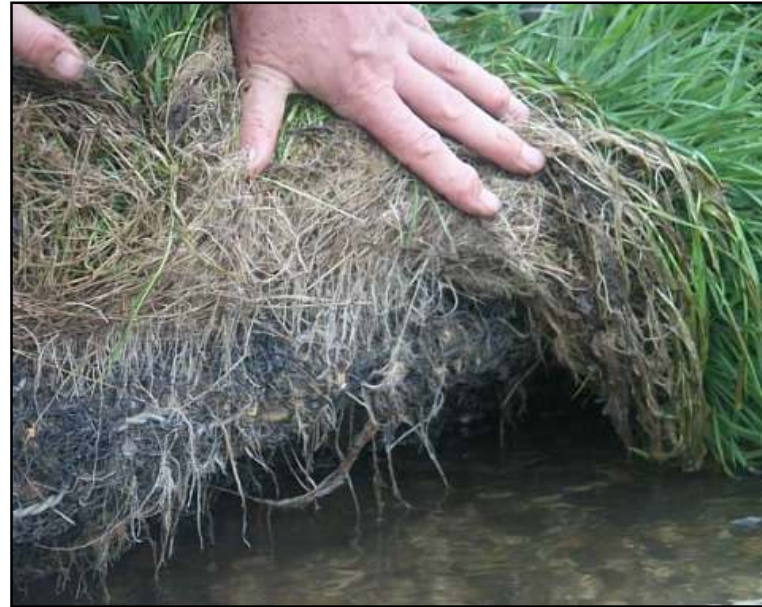
Natural Bank Side Cover.

- The geotextile shelf incorporates an overhang to provide bank side cover for various fish species.
- Trailing marginal vegetation protects the toe, and deflects erosive currents into the central channel where they belong.
