PROJECT EXCELLENCE AWARDS 2006

Project Name	Monk Bretton Bank Erosion Protection	
Project Details <i>(Brief description of works or appraisal / location / value)</i>	Construction of a brushwood mattress silt trap to repair severe river bank erosion. Located at the Monk Bretton A259 road bridge on the tidal River Rother, Rye (Kent Area). Cost of construction works: £280k Development of solution on other schemes including Rother Tidal Walls, Rye and Dartford Creek.	
Nominees/ Team Members	Name	Company
	Adam Schofield Miles Pickering Simon Cain Richard Hull Tim Connell	Halcrow Group Ltd Halcrow Group Ltd Cain Consultancy Environment Agency (Worthing NCPMS) Environment Agency Operations (Leigh)

Monk Bretton Bank Erosion Repair Scheme

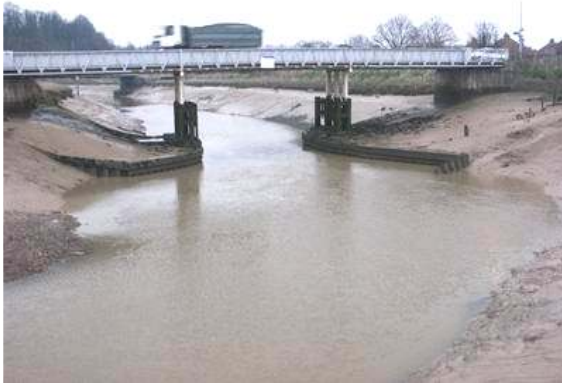
Photo 1: Monk Bretton Bridge

The A259 coast road crosses the River Rother at Rye – known as Monk Bretton Bridge. The nature of the bridge piers and river profile at the site has given rise to severe erosion process on the downstream side of the bridge, as indicated on Photograph 1. The site forms a small part of the extensive flood defence on the east bank of the tidal river Rother with the flood defence comprises a grass-covered embankment with a public footpath on the crest. The river is navigable, forming part of the Harbour of Rye and the locally important Fishmarket Quay lies on the opposite (west bank) of the river.

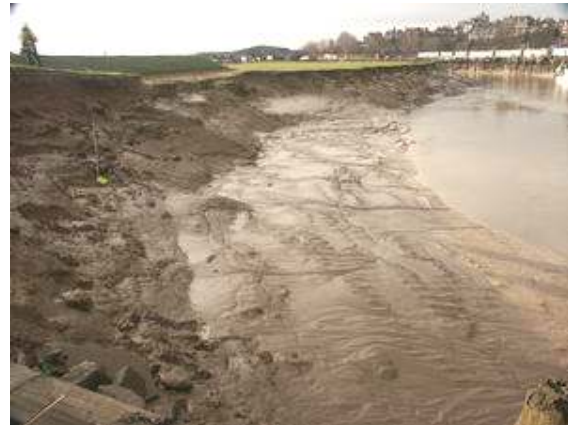
Photo 2: Scour hole at low tide

The bridge abutments are aligned in such a way that concentrated high velocity flows are directed through the constriction and against the face of the downstream embankment, causing a major scour hole and loss of the riverward face of the embankment extending to approximately 50% loss of the crest width. The scour hole was approximately 60m in length, and up to 4m deep. In conjunction with the scour process a scour hole in the bed of the river was recorded at approximately 10m depth below the crest of the embankment.

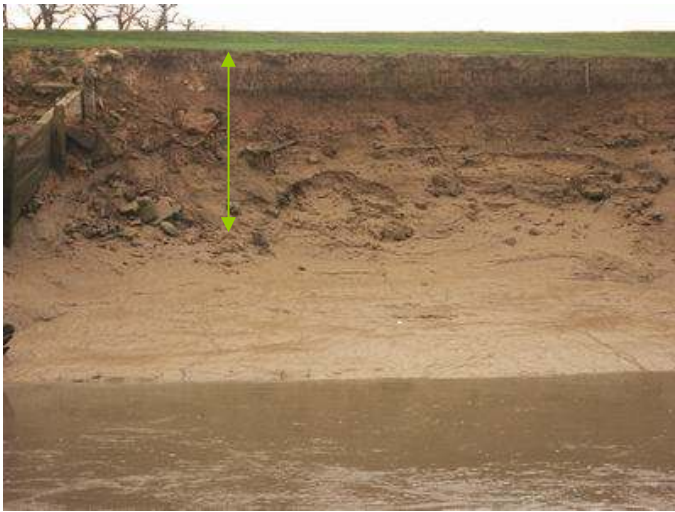
Photograph 3: Scour hole, with 2m vertical face

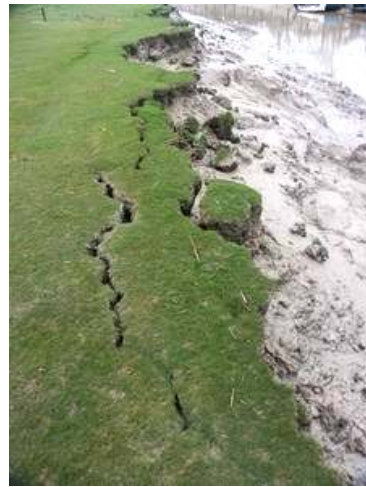
Photo 4: Deconstructing bank margin

If left unchecked it was clear that the scour process would continue, with erosion of the embankment. Given the nature of the erosion process a sudden dramatic geotechnical failure of the remainder of the embankment could not be ruled out, exposing the property to major risk of life- threatening flooding.

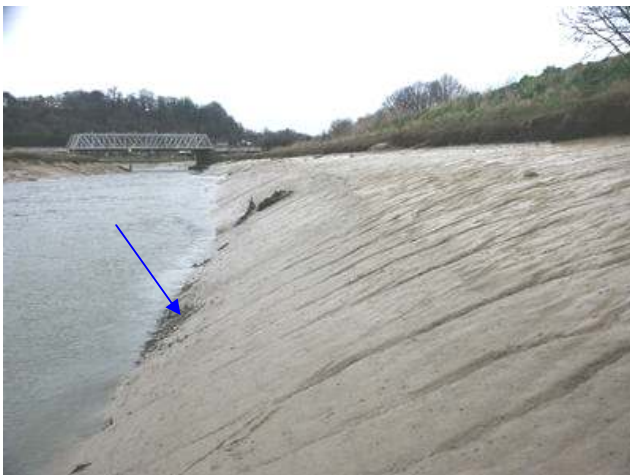
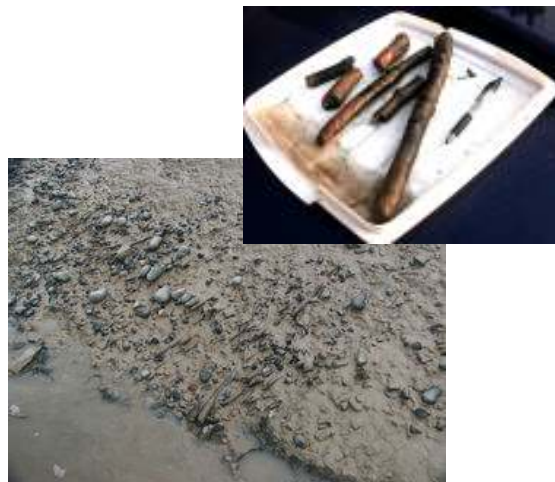
During investigation of the site the channel upstream of the Monk Bretton Bridge was inspected. The channel is unusual in that the left hand bank features a completely smooth and stable profile, whilst the opposite bank is actively undergoing slump and deconstruction. Closer inspection revealed that the bank profile has been achieved via the accretion of a pre-formed brushwood sediment trap.

Photograph 5-7: Ancient hazel faggot bank revetment upstream of Monk Bretton Bridge

The age of the installation of the brushwood could not be identified readily, but since no knowledge of its existence was known by any local EA staff, it has been presumed to be at least 50-60 years old, and probably far older.

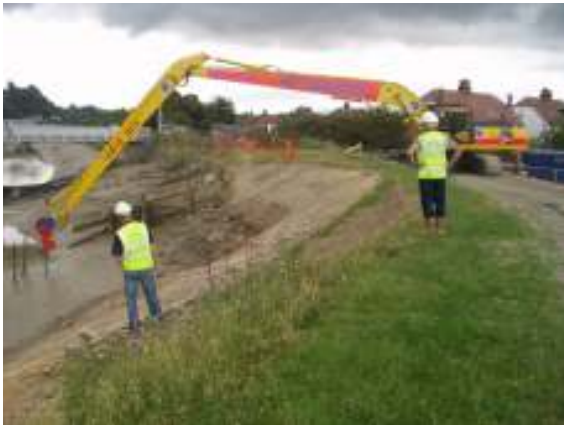
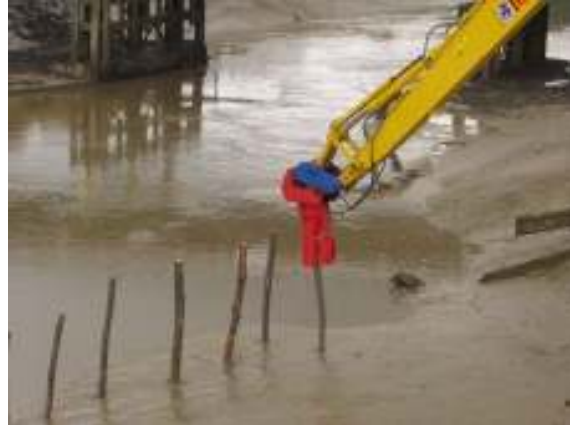
Photograph 8-9: Placement of the timber stakes using placing tool

Following a near-surface UXB survey (cheaper than a deep penetrative UXB survey required for sheet piling) the construction of a stake matrix was initiated. To avoid the need for labourers to undertake this manually within the tidal river silts, a special tool was used fabricated by the machine plant supplier to pick and place the stakes using a long-arm reach machine. This was planned during design discussions as part of the Designer's Risk Assessment by the team.

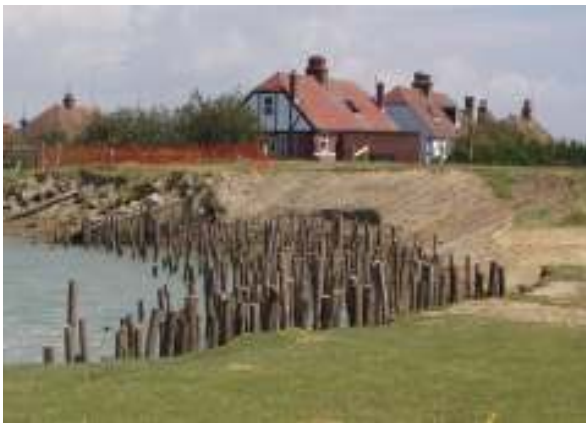
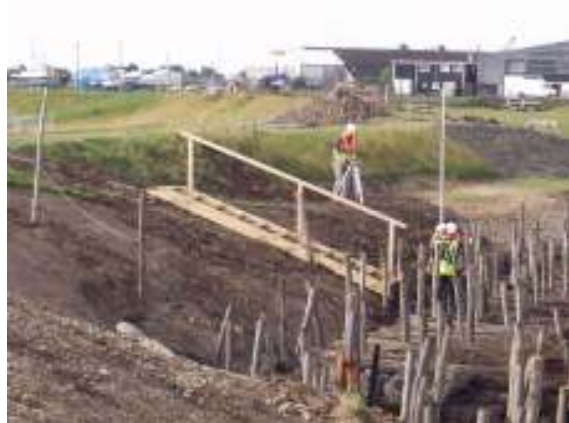
Photographs 10-11: Completion of stake matrix and placement of faggots with temporary step access

In addition to reduced H&S risks associated with working in the river, there were also significant economic benefits from adopting this more rapid method of construction. The stake matrix was completed and hazel faggots then installed. These were delivered in 300mm to 400mm tied bundles, up to 4m in length. Placement of the faggots was undertaken using a combination of hand and machine to achieve the required design profile.

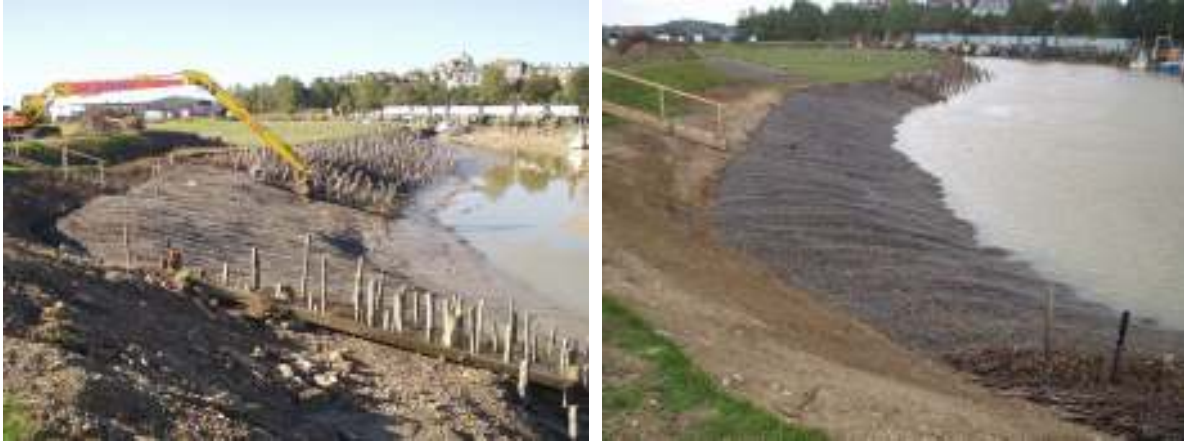
Photograph 12-13: Mattress with netting installation

The faggots are bound together in-situ to form the mattress. Once the faggot mattress is placed to required profile, the timber stakes are trimmed, and the mattress is held to the timber stakes by installation of rock netting over the top.

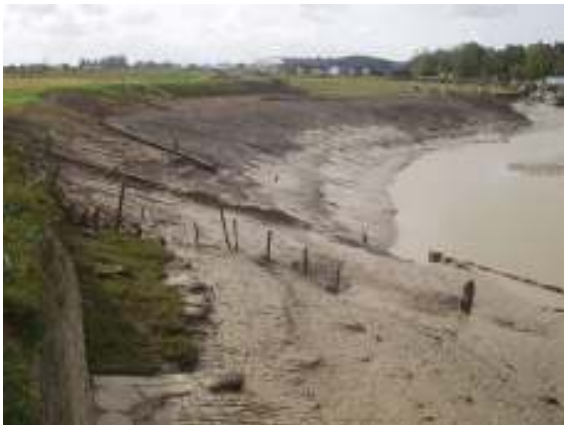
Photograph 14: Mattress at end of construction

The brushwood mattress has accreted as predicted – even during construction it was found that the toe of the mattress was soon invisible following completion. Lessons that have been learnt over the past year during monitoring of the mattress are:

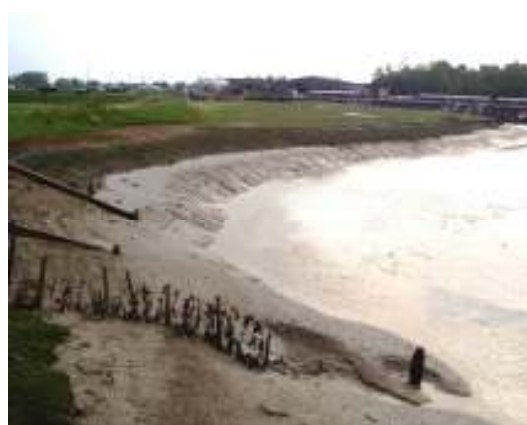
Photograph 15: 12 months post completion

- Once accreted the mattress settles, thus exposing the top of the stakes and netting at the top level of the design profile. At the appropriate time either the stakes and mesh needs to be lowered or removed such that it does not become a maintenance liability.
- The accretion rate up to 500mm of MHWS level (top of design level) was quick at this site (about 6 months). However since the suspended sediment load at the top of the tide is lower (slower speed) the final accretion to design level is a much more gradual process, and it may be that artificial placement to the design level would improve aesthetics and then assist natural vegetation process to achieve the final desired natural effect.
